INITIAL STUDY AND MITIGATED NEGATIVE DECLARATION

11022-11044 Garvey, Mixed Use Project

Tetra Tech, Inc.
17885 Von Karman Avenue, Suite 500
Irvine, CA 92614-6213

November 2014

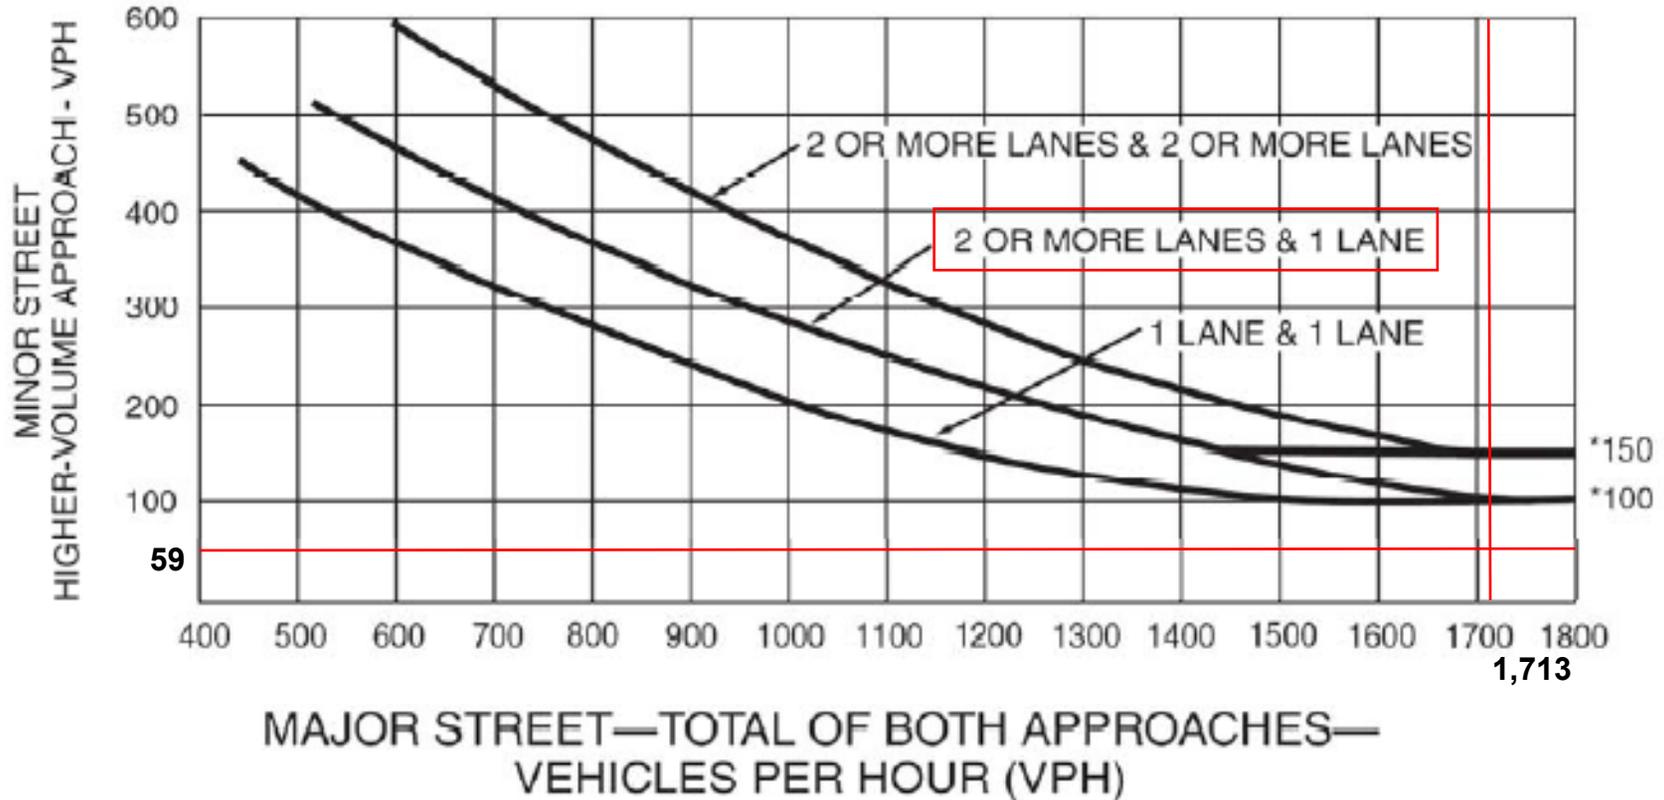
#1 CONSOL AVENUE/GARVEY AVENUE
EXISTING PLUS PROJECT
AM PEAK HOUR
WARRANT NOT SATISFIED

*Note: 150 vph applies as the lower threshold volume for a minor-street approach with two or more lanes and 100 vph applies as the lower threshold volume for a minor-street approach with one lane.

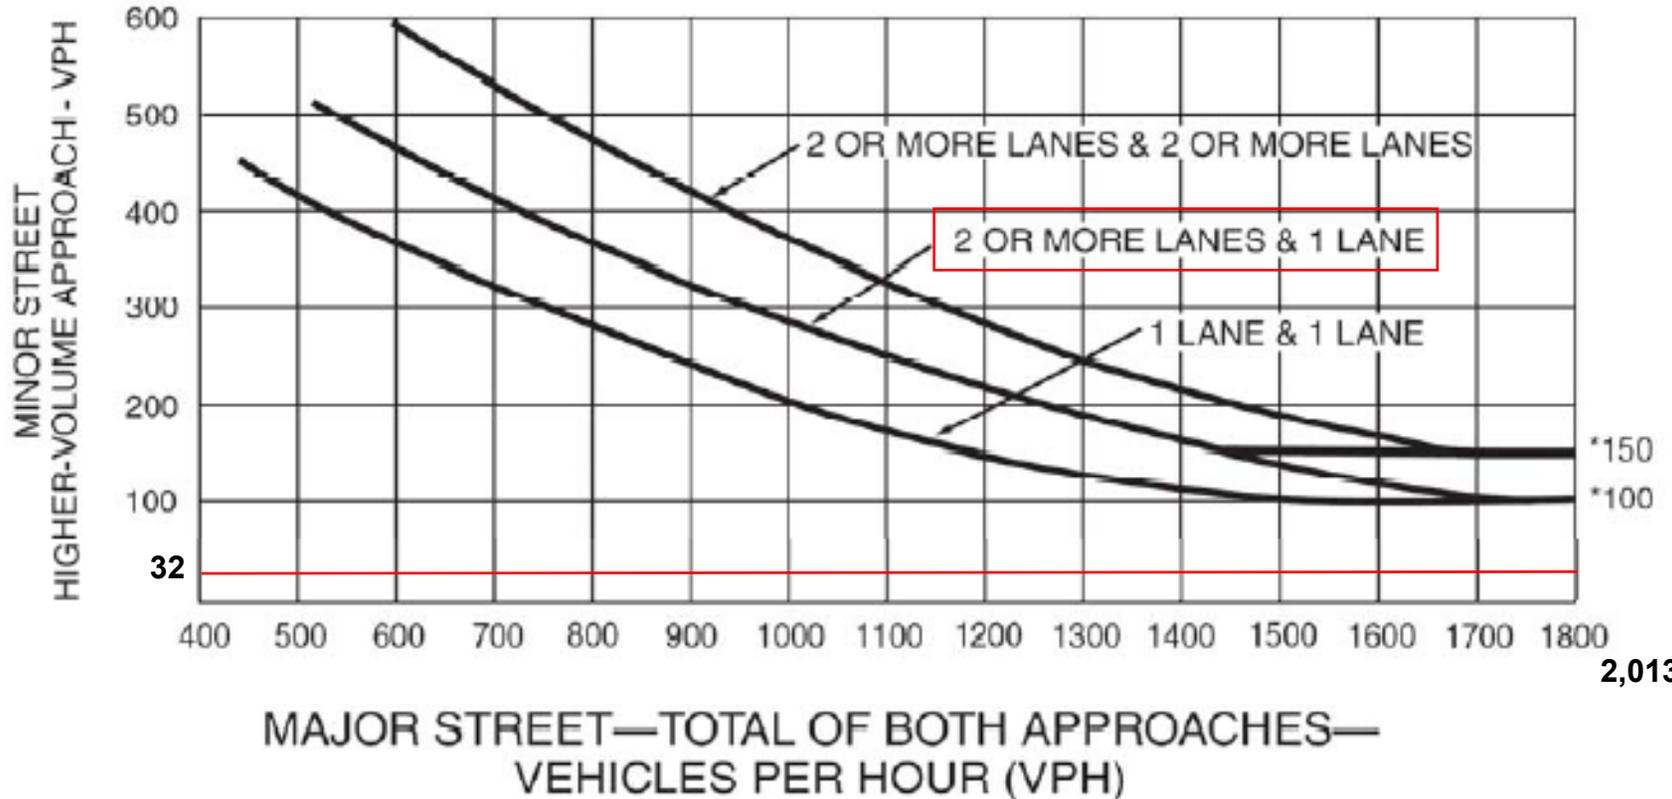
#1 CONSOL AVENUE/GARVEY AVENUE
EXISTING PLUS PROJECT
PM PEAK HOUR
WARRANT NOT SATISFIED

*Note: 150 vph applies as the lower threshold volume for a minor-street approach with two or more lanes and 100 vph applies as the lower threshold volume for a minor-street approach with one lane.

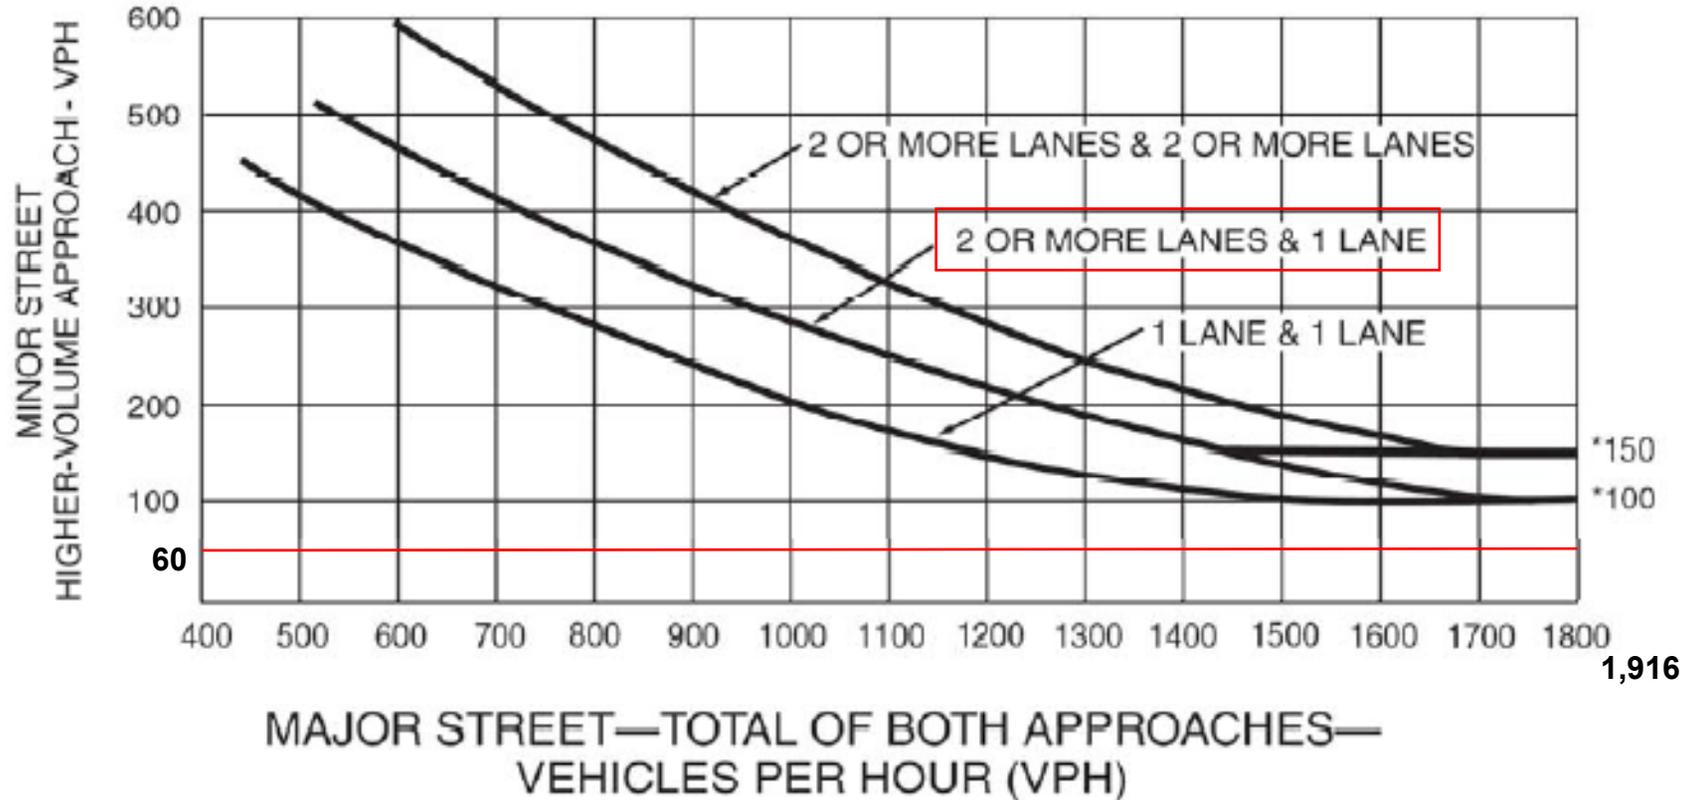
#1 CONSOL AVENUE/GARVEY AVENUE
OPENING YEAR PLUS PROJECT
AM PEAK HOUR
WARRANT NOT SATISFIED

*Note: 150 vph applies as the lower threshold volume for a minor-street approach with two or more lanes and 100 vph applies as the lower threshold volume for a minor-street approach with one lane.

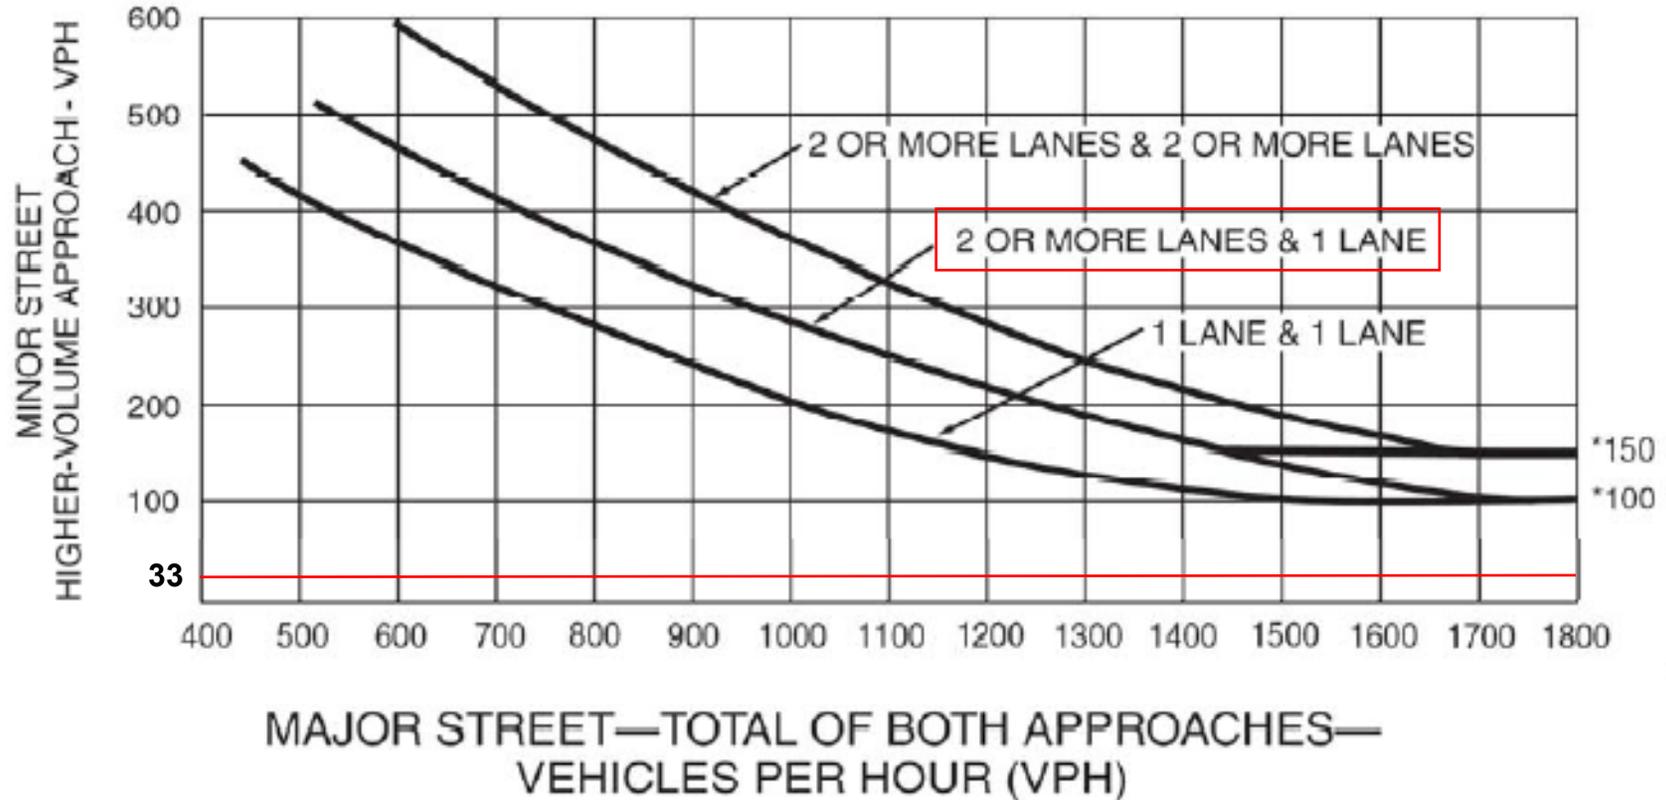
#1 CONSOL AVENUE/GARVEY AVENUE
OPENING YEAR PLUS PROJECT
PM PEAK HOUR
WARRANT NOT SATISFIED

*Note: 150 vph applies as the lower threshold volume for a minor-street approach with two or more lanes and 100 vph applies as the lower threshold volume for a minor-street approach with one lane.

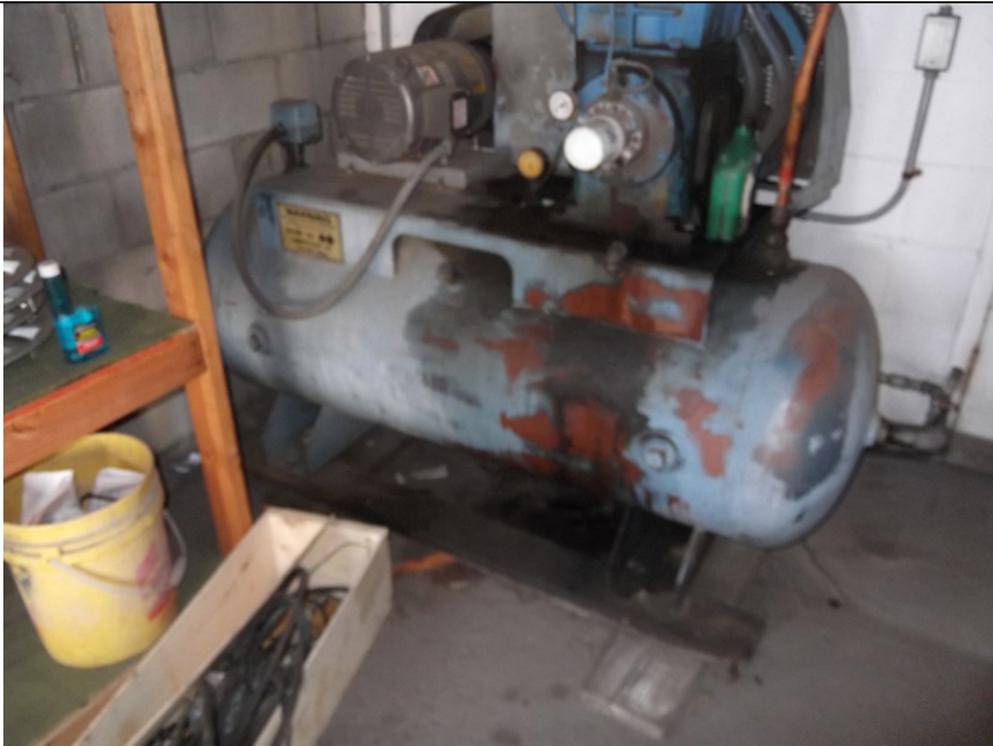
Photograph No. 2

Compressor with minor staining in the shed east of the building.

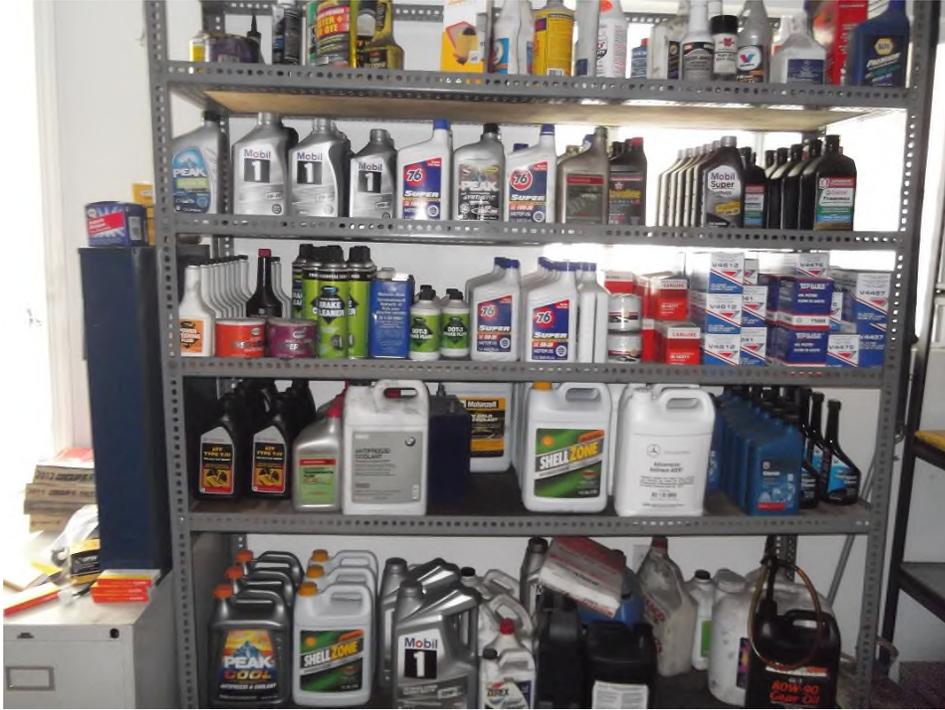
Photograph No. 3

Shelved storage of small volumes of hazardous materials such as motor oil, antifreeze, and lube.

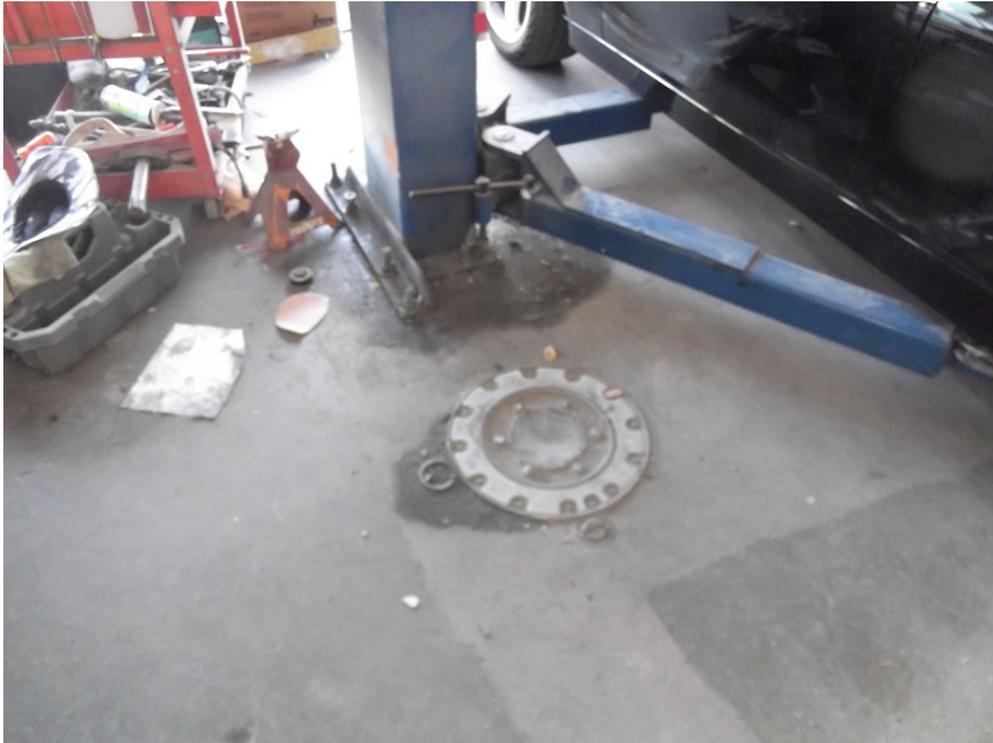
Photograph No. 4

One of two former hydraulic lifts in the repair area.

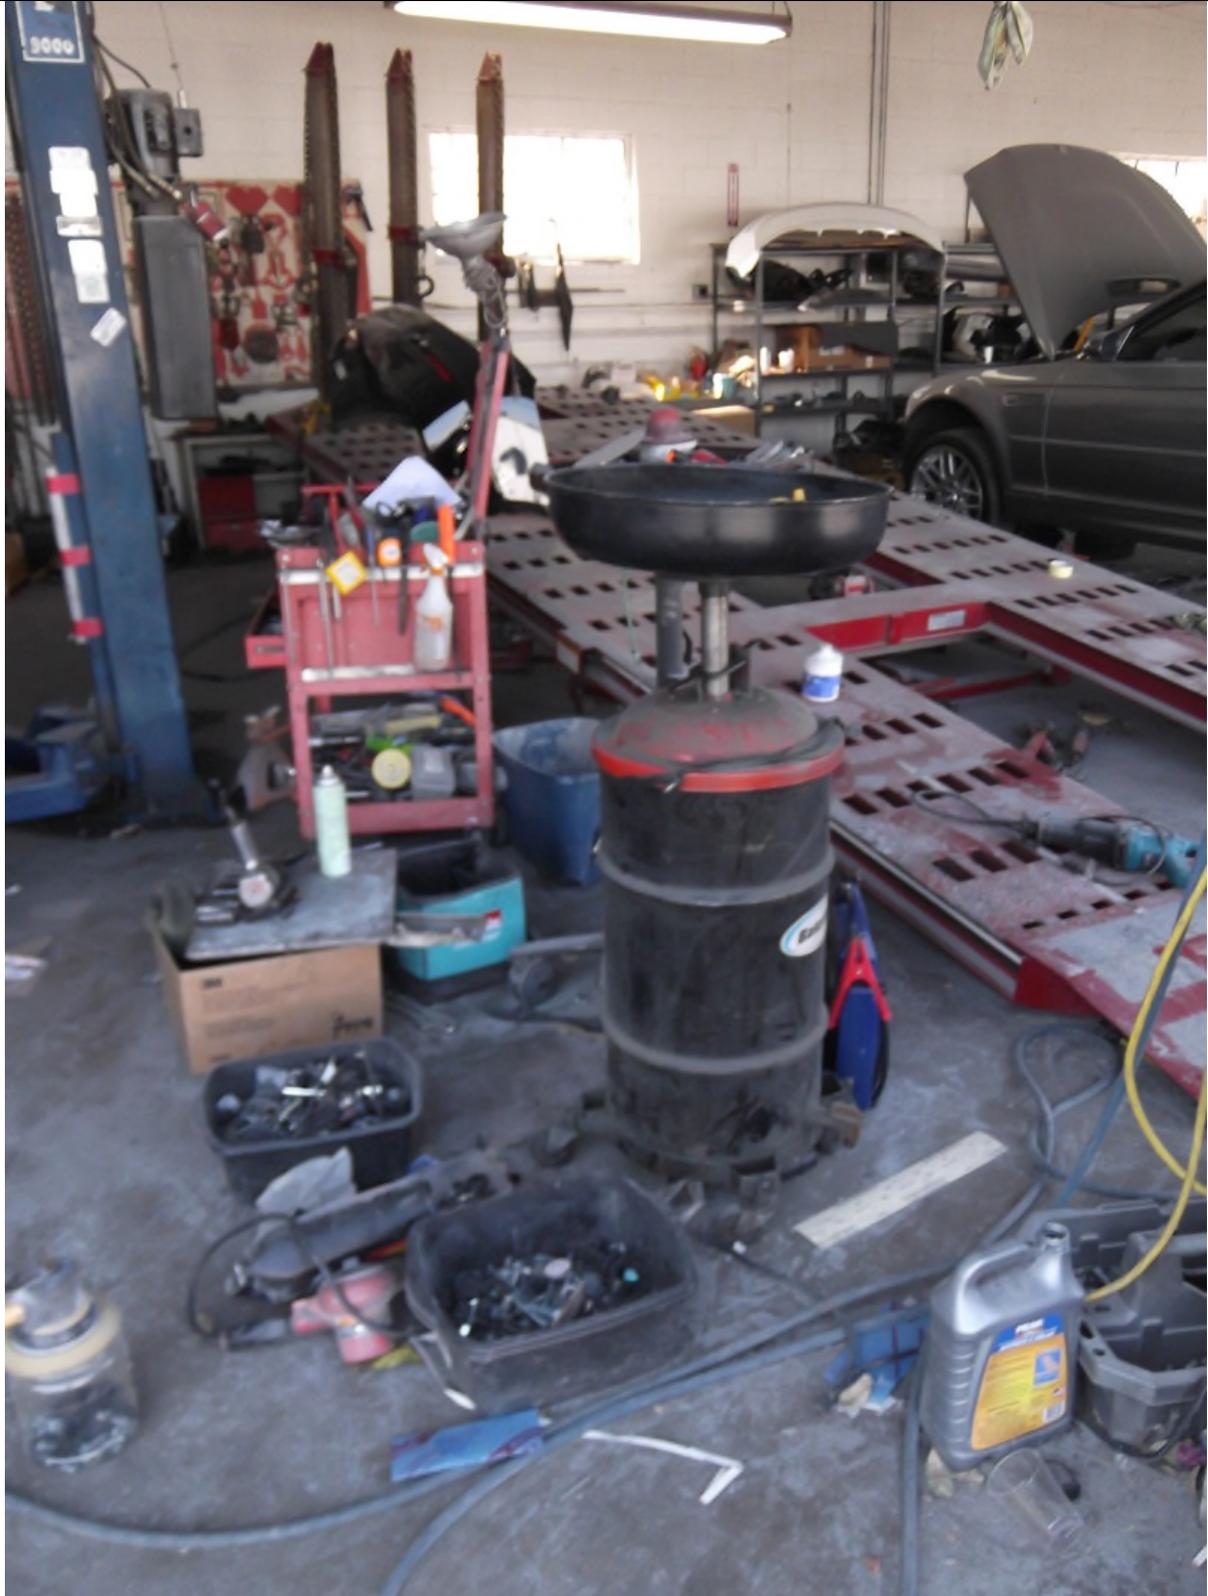
Photograph No. 5

Oil drum and equipment and parts in the repair area.

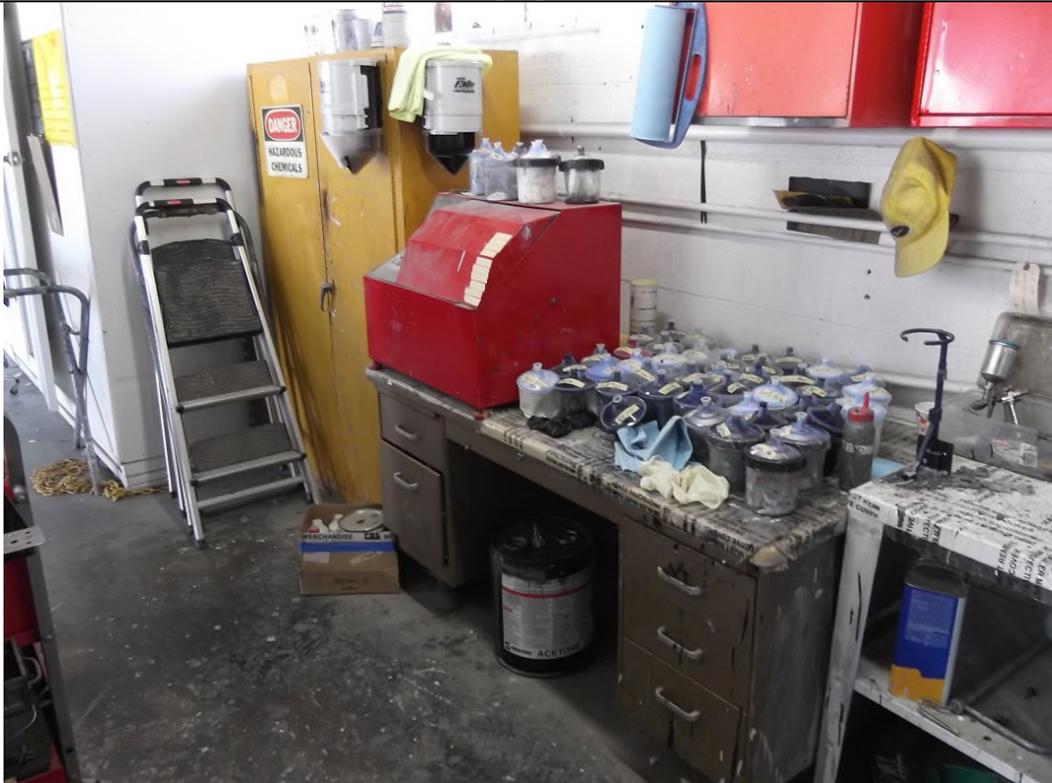
Photograph No. 7

Example of paint and small volume hazardous materials storage.

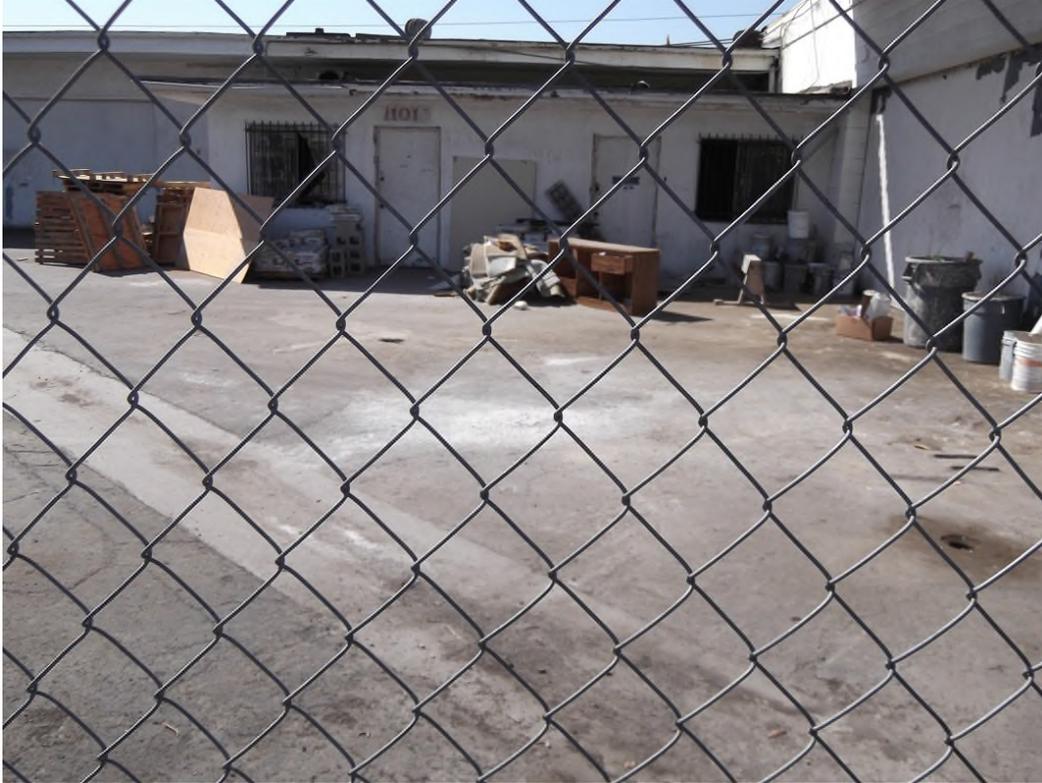
Photograph No. 17

Fenced yard behind (east of) the flooring warehouse, with unknown subsurface feature on the right..

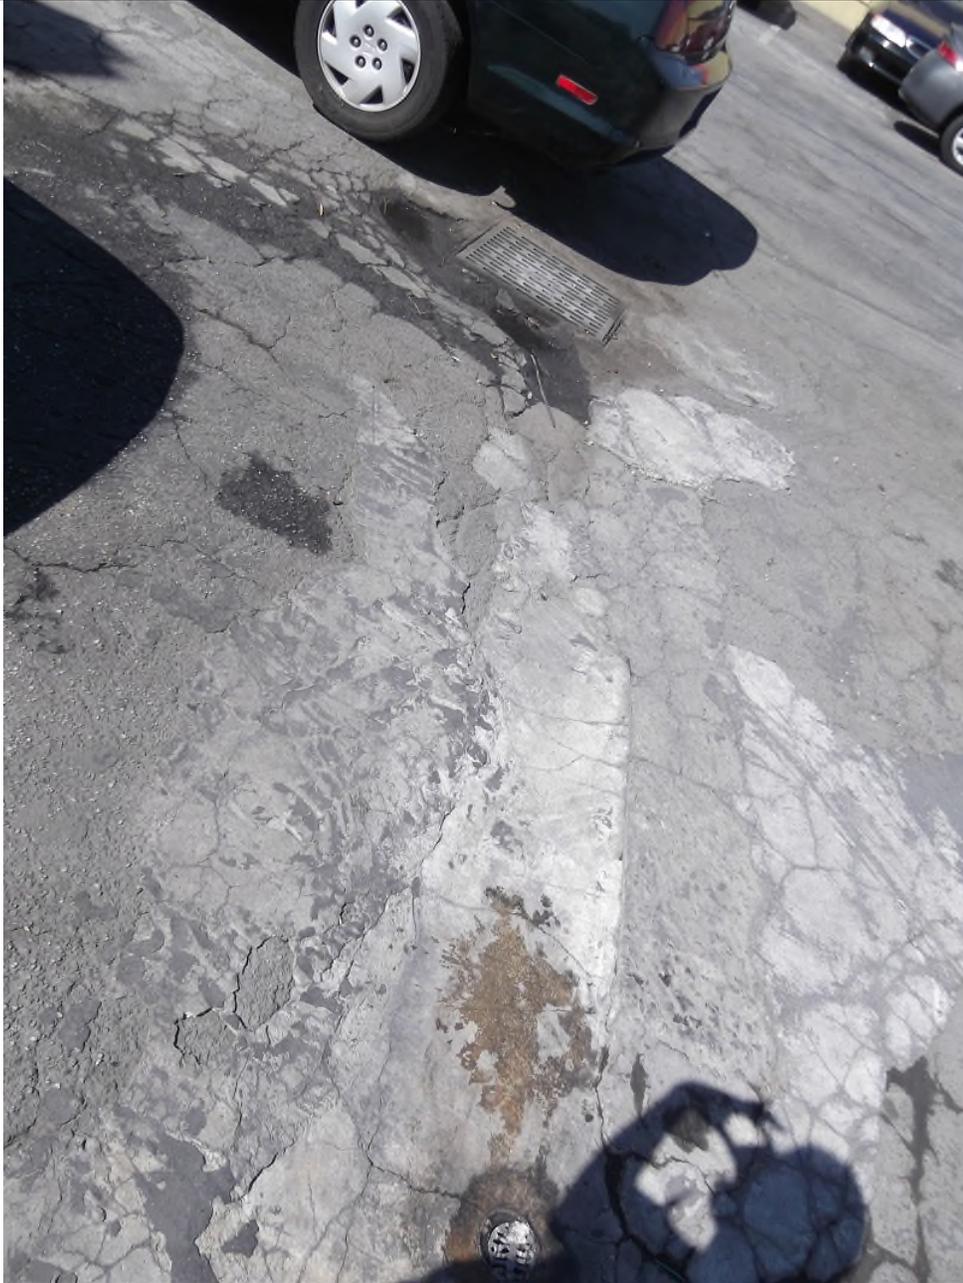
Photograph No. 20

Drains in the lot of the central car sales lot of the Site.

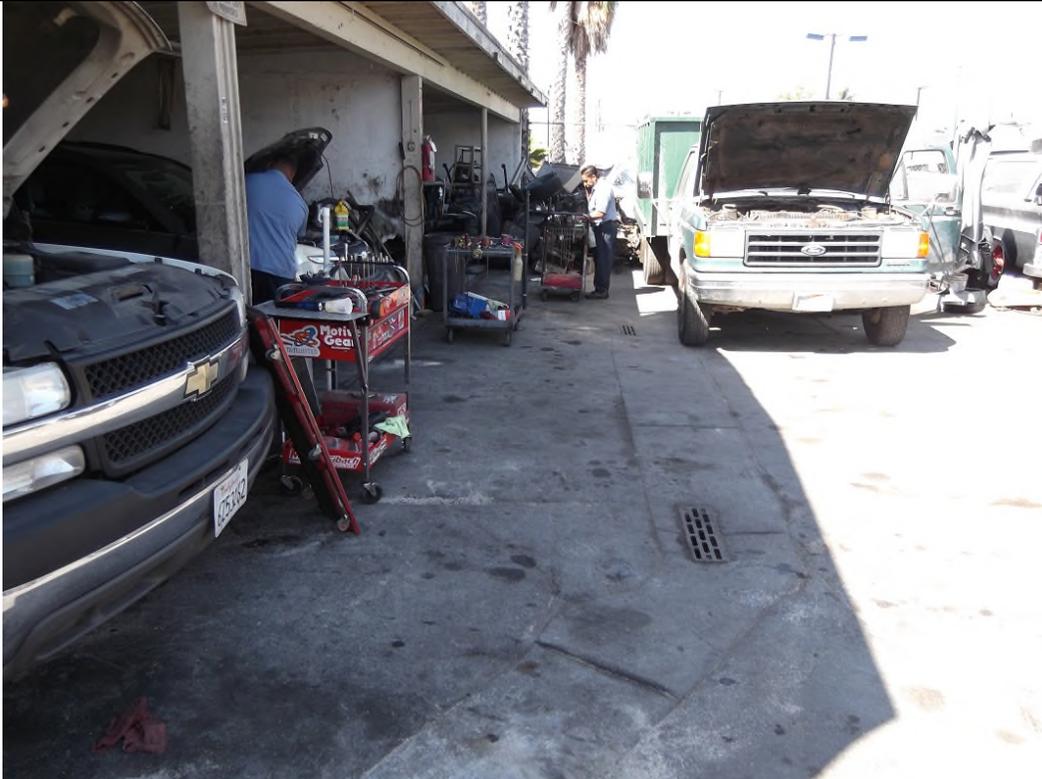
Photograph No. 24

View of the main service bays at the auto repair facility.

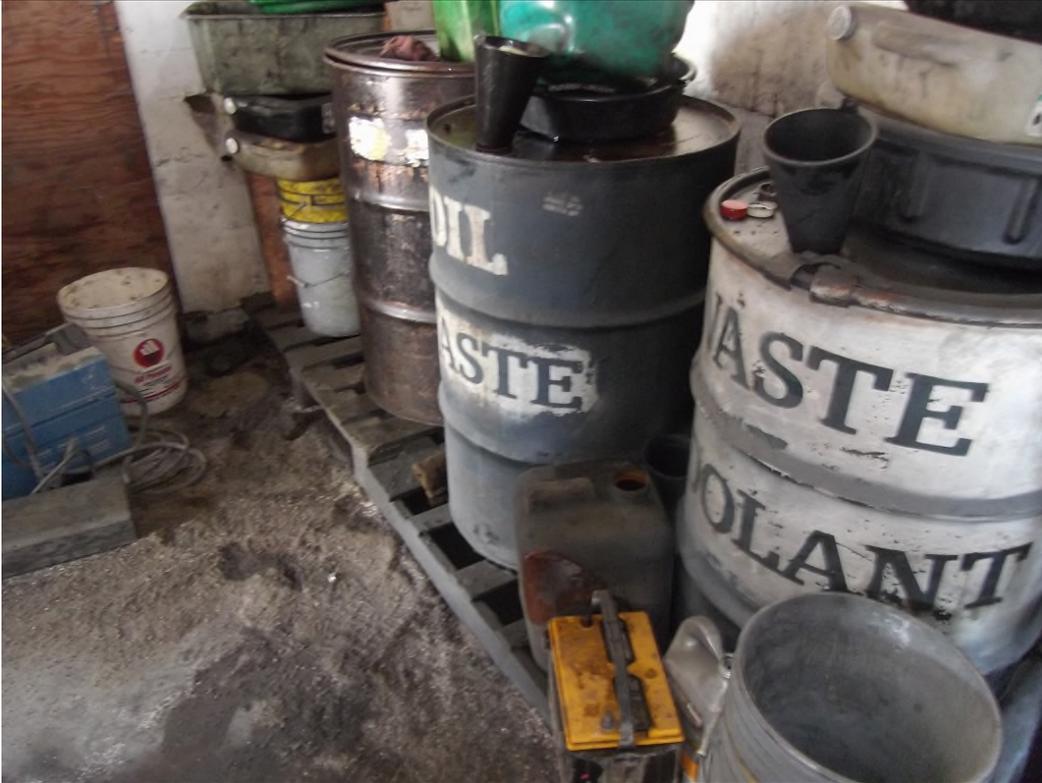
Photograph No. 25

Waste oil and coolant drums with floor staining and kitty litter spread to address spills.

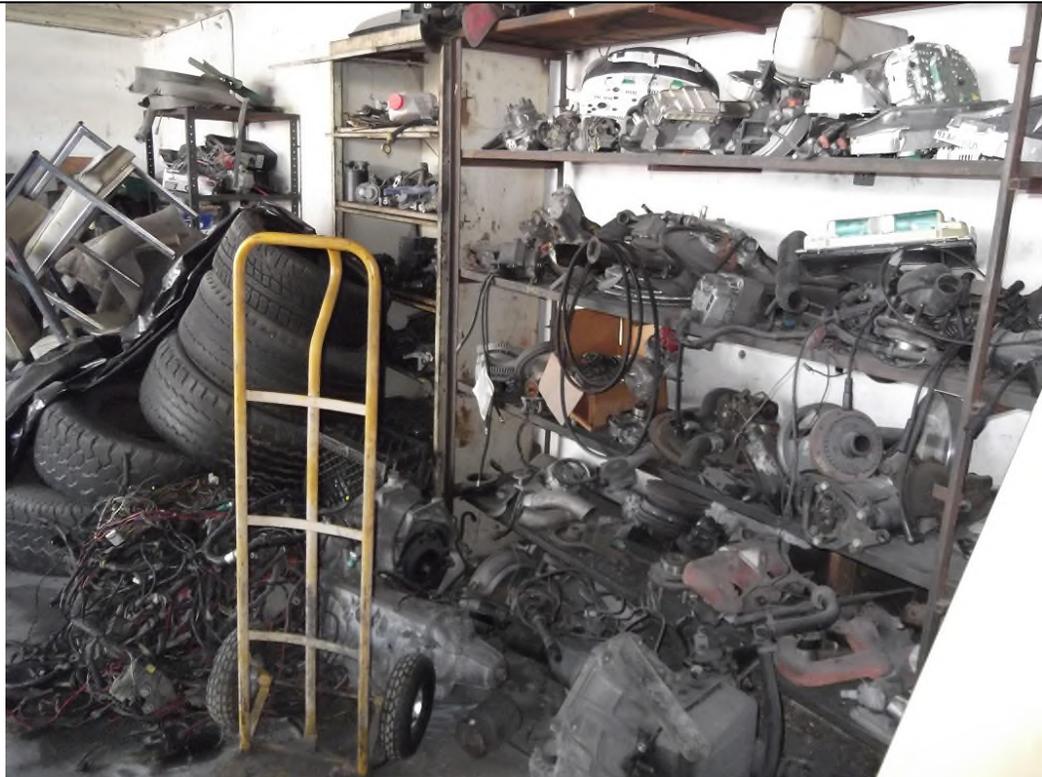
Photograph No. 26

Parts and tires stored in the service bays.

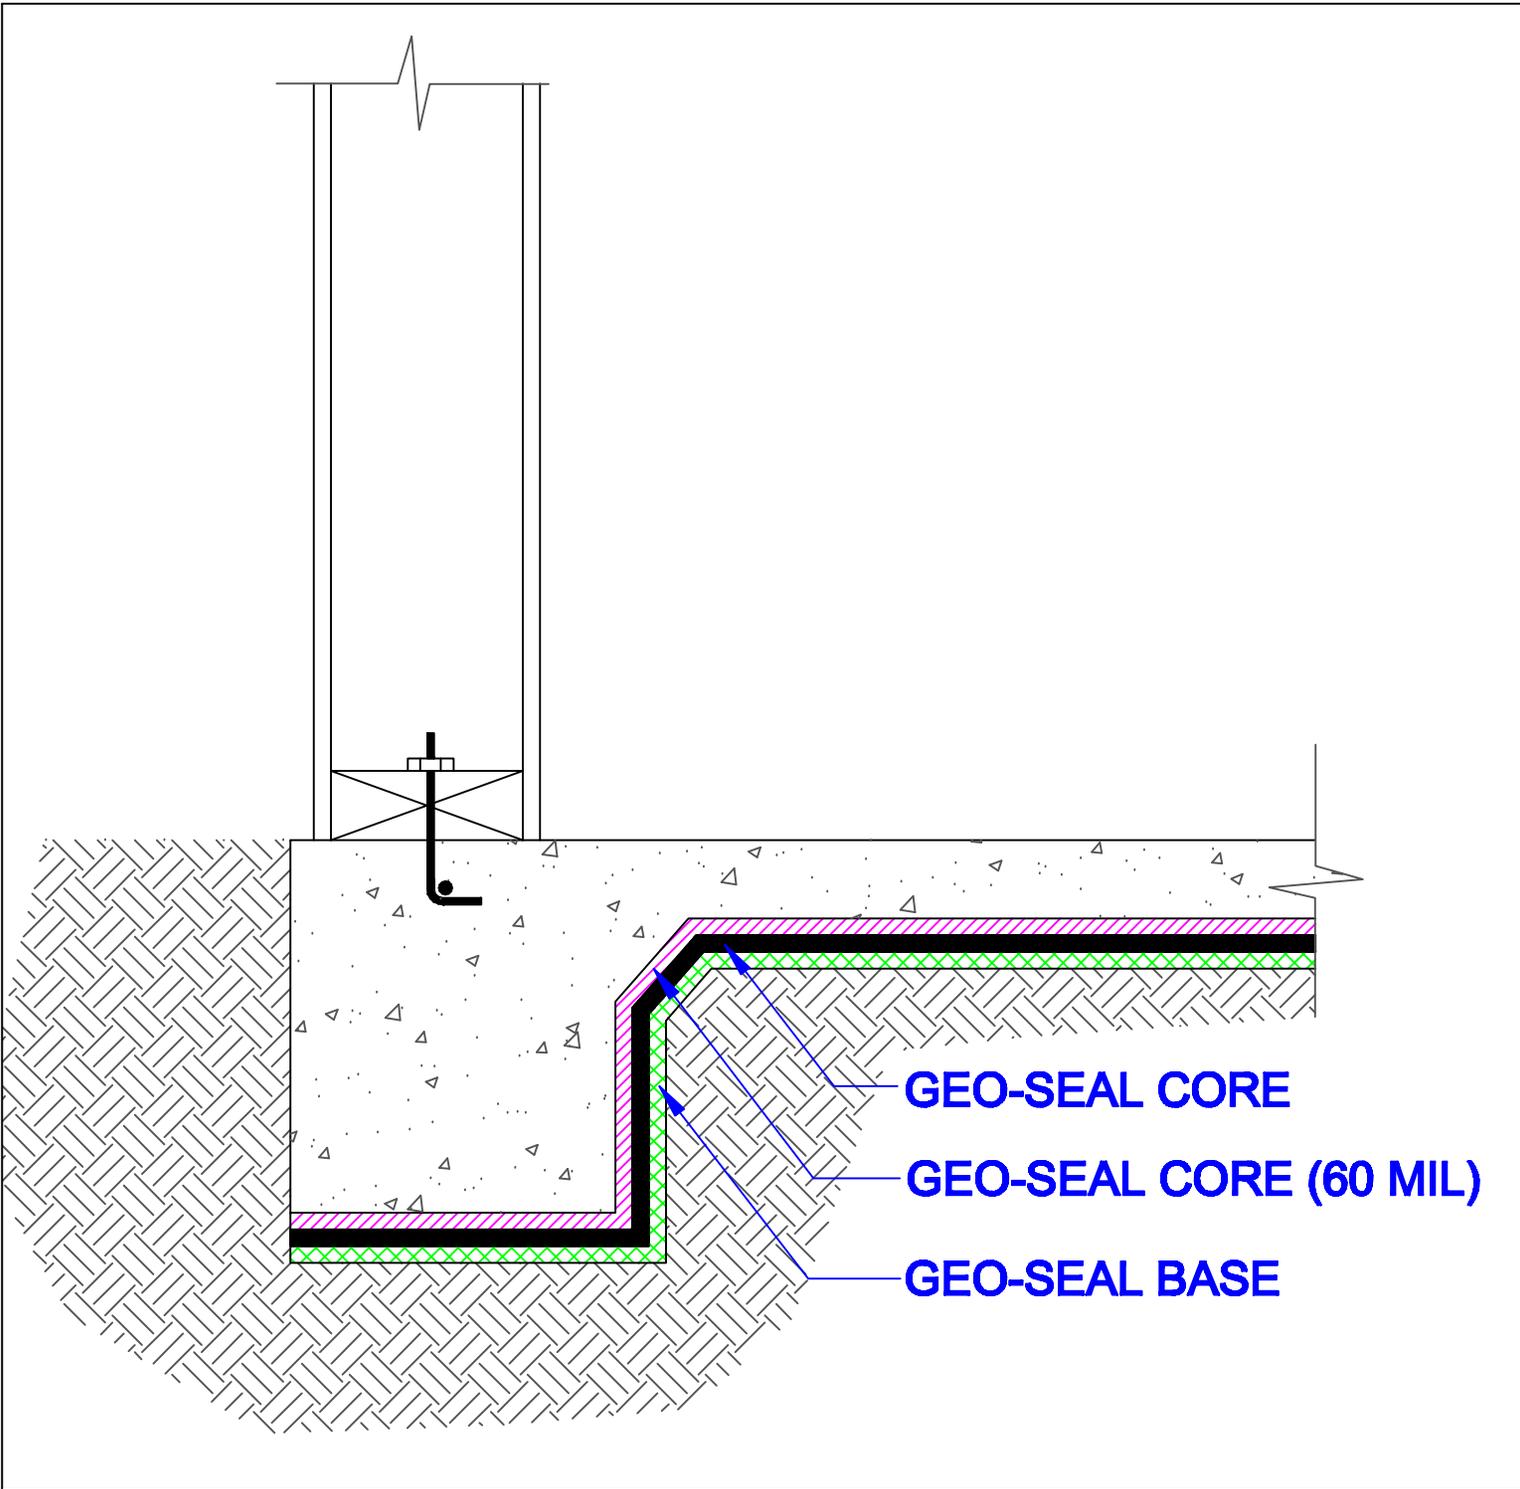
**TERMINATION
SEQUENCE**

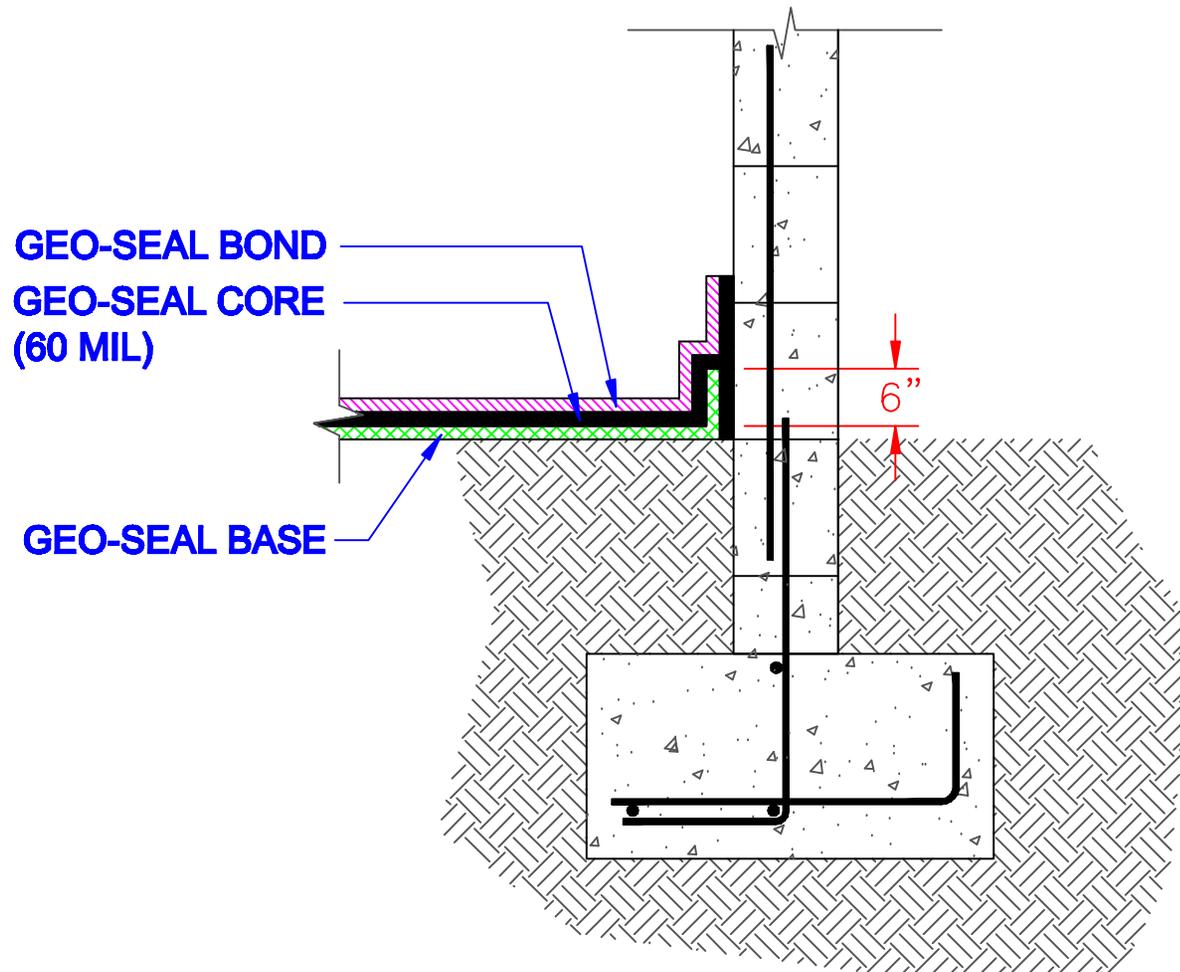
**VERTICAL
TERMINATION DETAIL**
